DEPARTMENT OF THE INTERIOR
UNITED STATES GEOLOGICAL SURVEY

THE
SAN FRANCISCO EARTHQUAKE AND FIRE

APRIL 18, 1906

AND THEIR EFFECTS ON STRUCTURES AND
STRUCTURAL MATERIALS

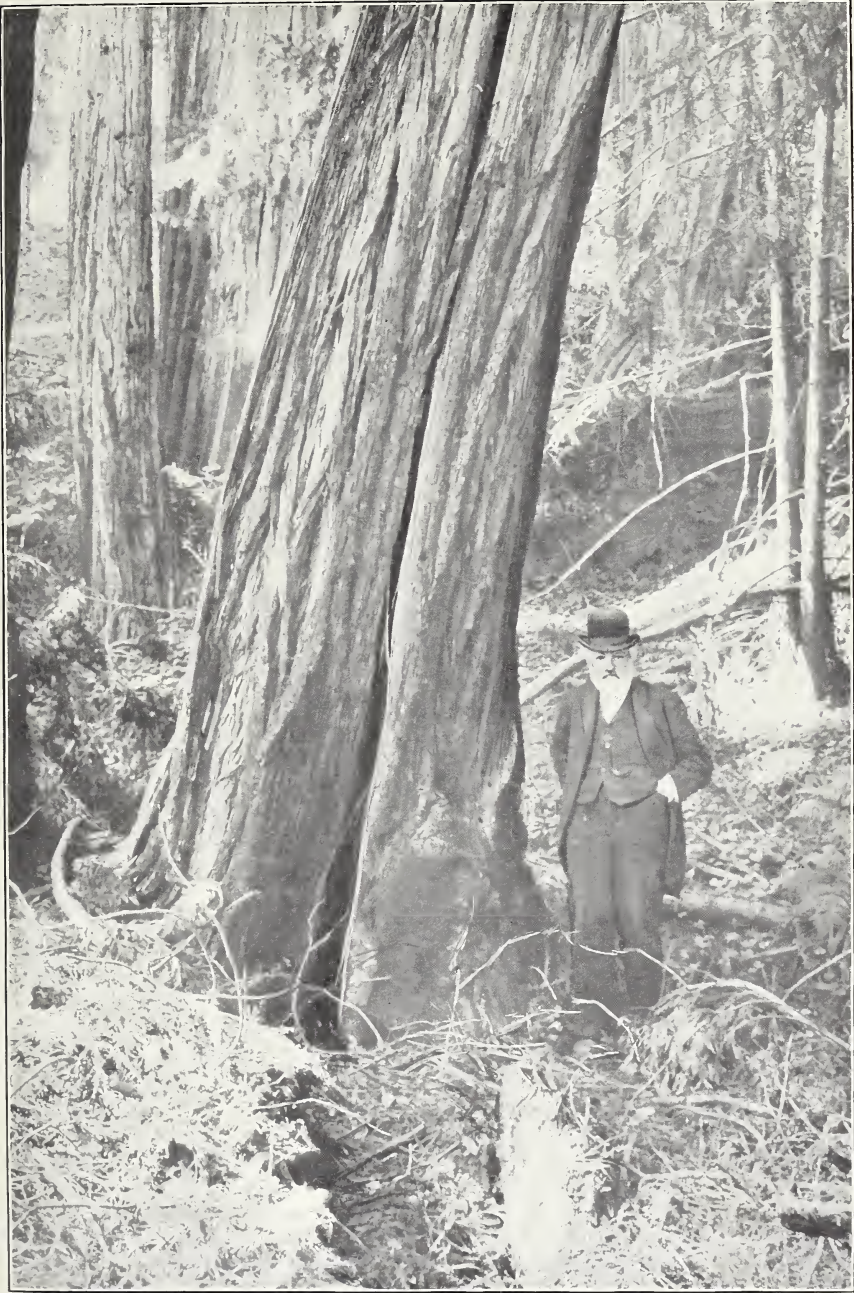
REDWOOD TREE 6 FEET IN DIAMETER ON LINE OF FAULT SOUTH OF FORT ROSS.

The tree was split to a height of 35 feet, although the horizontal displacement was slight. The opening is wedge-shaped at the base, running from a width of 8 inches on the side shown to a fine crack on the farther side. Photograph by Richard L. Humphrey.

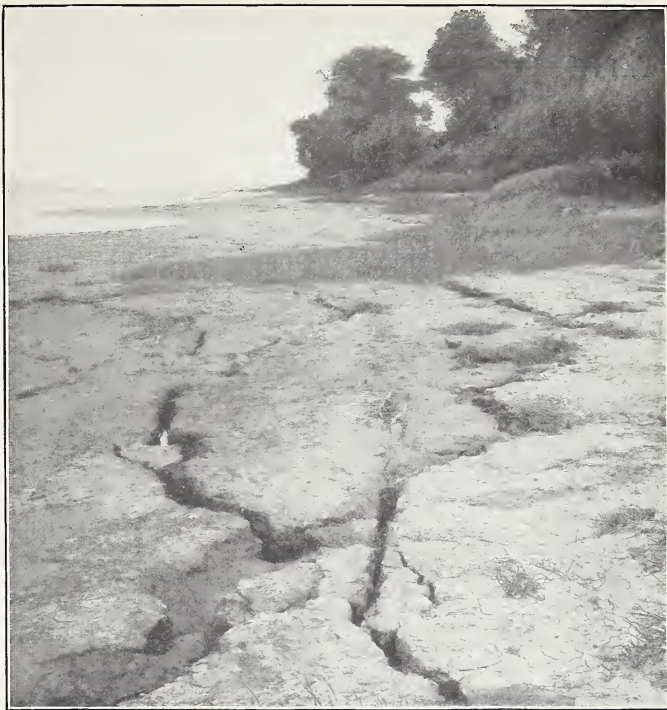
A. SECONDARY CRACKS, SHORE OF BOLINAS LAGOON.

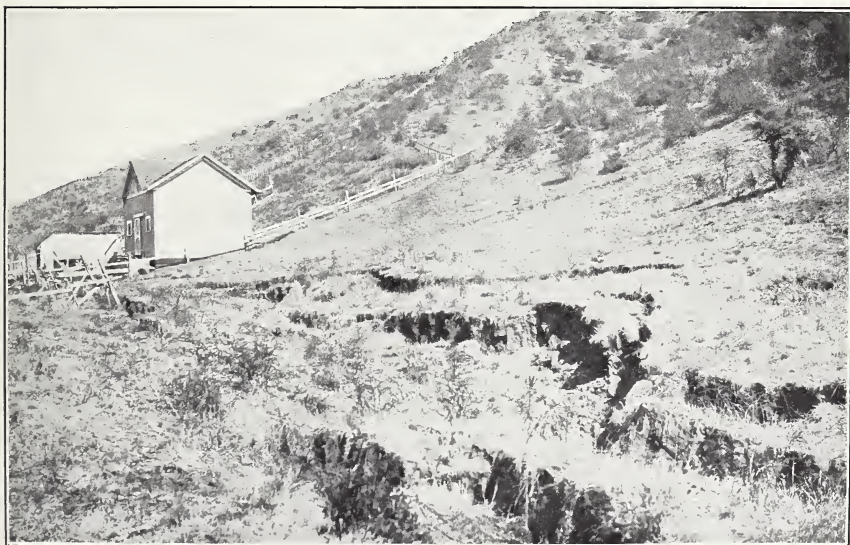
B. SECONDARY CRACKS, WITH SETTLING, BOLINAS.

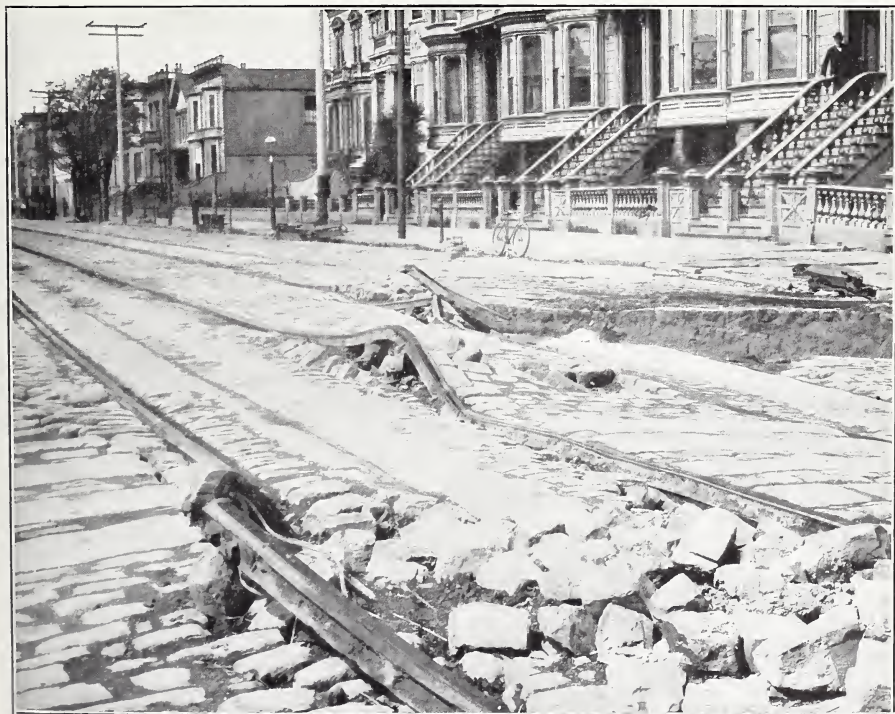
B. BUCKLING CAUSED BY EARTH FLOW, HOWARD STREET, SAN FRANCISCO.

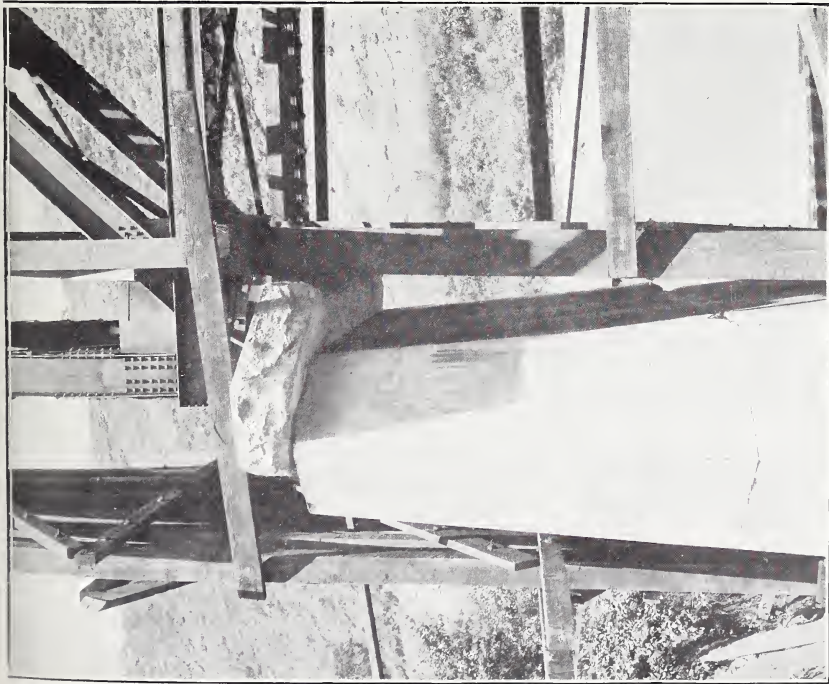
8. RACKING AND SPALLING OF CONCRETE PIER DUE TO EARTHQUAKE. Near south abutment of Southern Pacific Railroad bridge over Pajaro River. Photograph by Richard L. Humphrey.

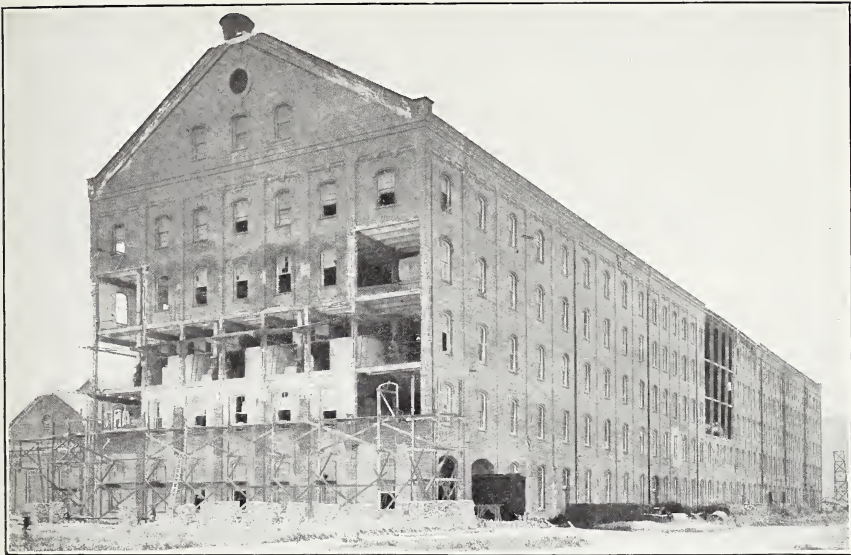
A. EFFECT OF EARTHQUAKE ON THE END AND THE INSUFFICIENTLY BRACED CENTRAL PORTION OF A BRICK BUILDING, SPRECKELS'S SUGAR MILL, ABOUT 4 MILES SOUTH OF SALINAS.

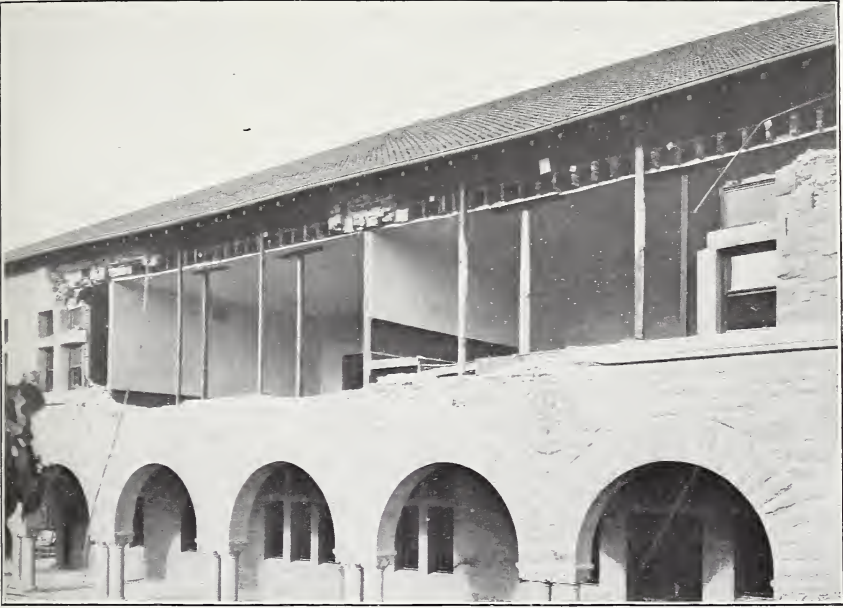
A. EARTHQUAKE DAMAGE DUE TO LACK OF TIE AND BRACING, GEOLOGICAL DEPARTMENT, LELAND STANFORD JUNIOR UNIVERSITY.

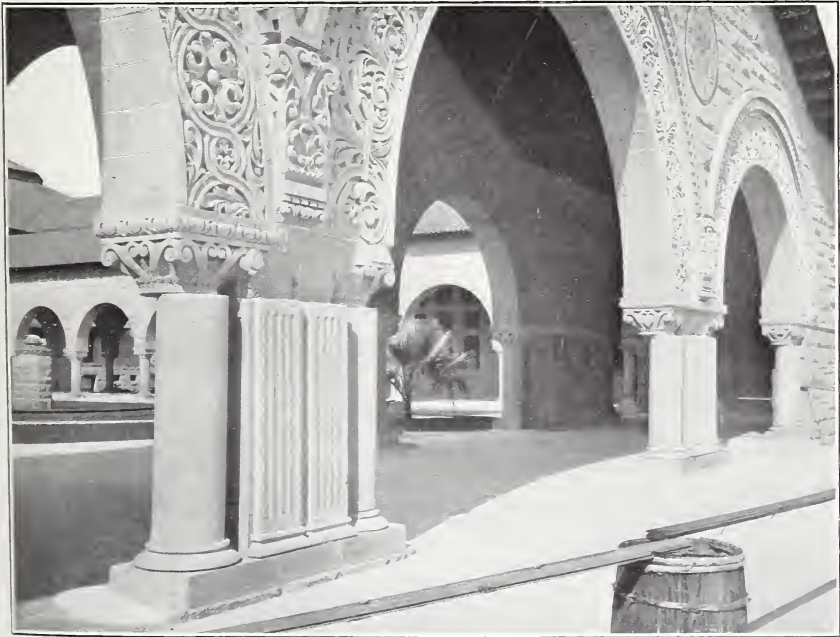
B. EARTHQUAKE EFFECT ON ARCHES, LELAND STANFORD JUNIOR UNIVERSITY.

Spalling of caps and movement of upper part of columns. Photograph by Richard L. Humphrey.

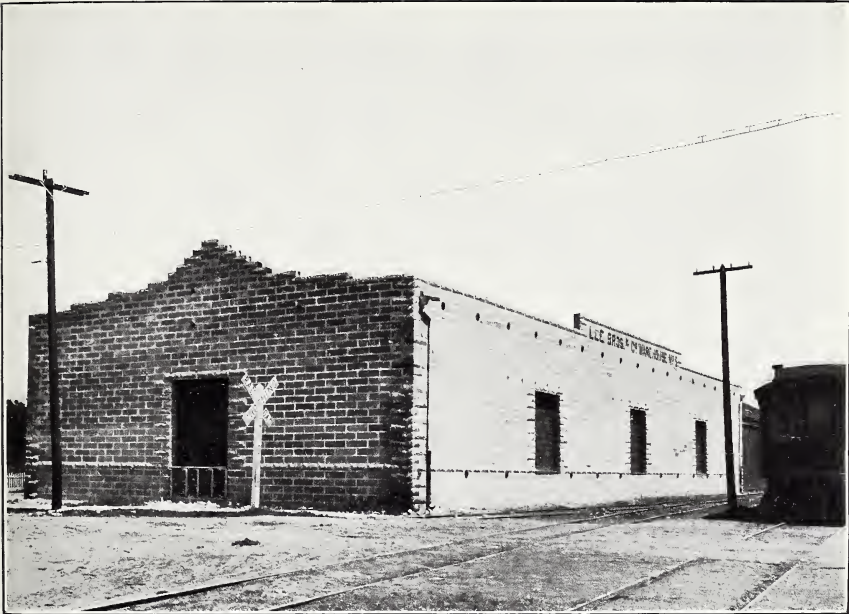
A. ENDURANCE OF WALLS TIED TOGETHER WITH STEEL RODS, LEE BROTHERS' WAREHOUSE, SANTA ROSA.

Slightly damaged at cornice. The few blocks which were thrown down by the earthquake were replaced previous to the taking of the photograph.

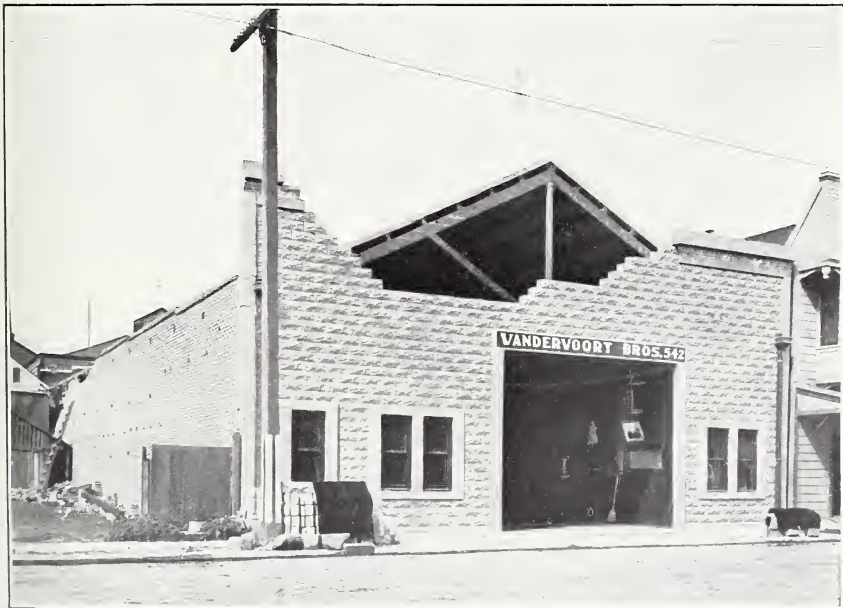
B. WALL THROWN DOWN BY EARTHQUAKE VIBRATIONS OF ROOF TRUSSES WHICH WERE NOT TIED TO WALL, VANDERVOORT BROTHERS' LIVERY, PALO ALTO.

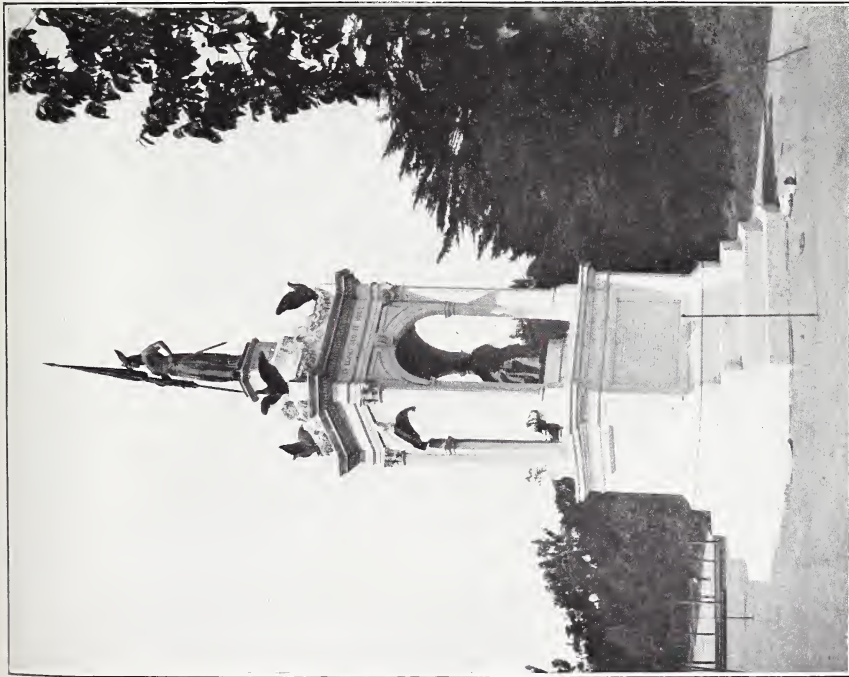
4. LOOSENING OF ARCH STONES AND SPALLING OF COLUMNS BY EARTHQUAKE, FRANCIS SCOTT KEY MONUMENT, GOLDEN GATE PARK, SAN FRANCISCO.

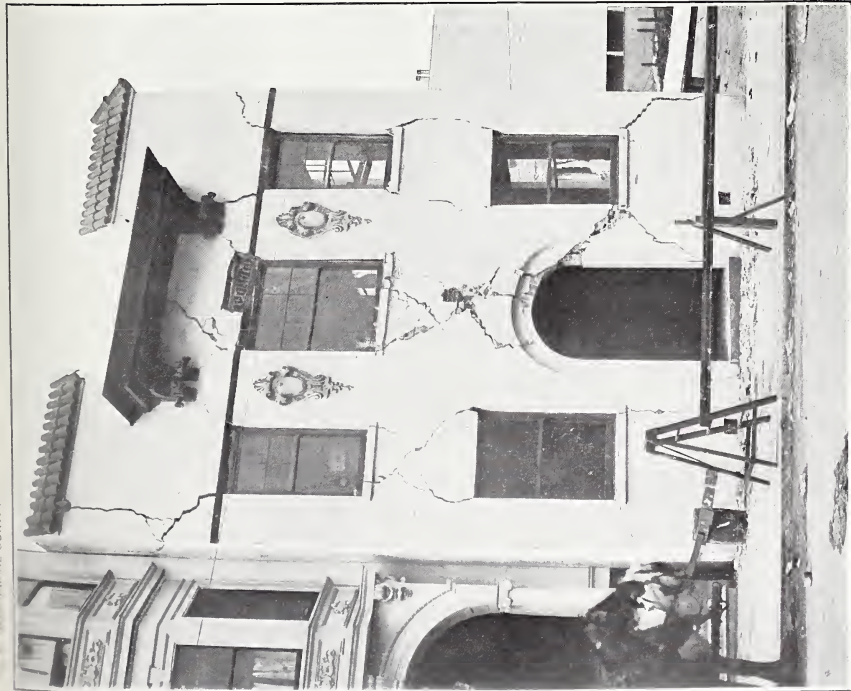
41. X CRACKS IN BRICKWORK, CAUSED BY ROCKING, HOUSE IN SAN FRANCISCO.

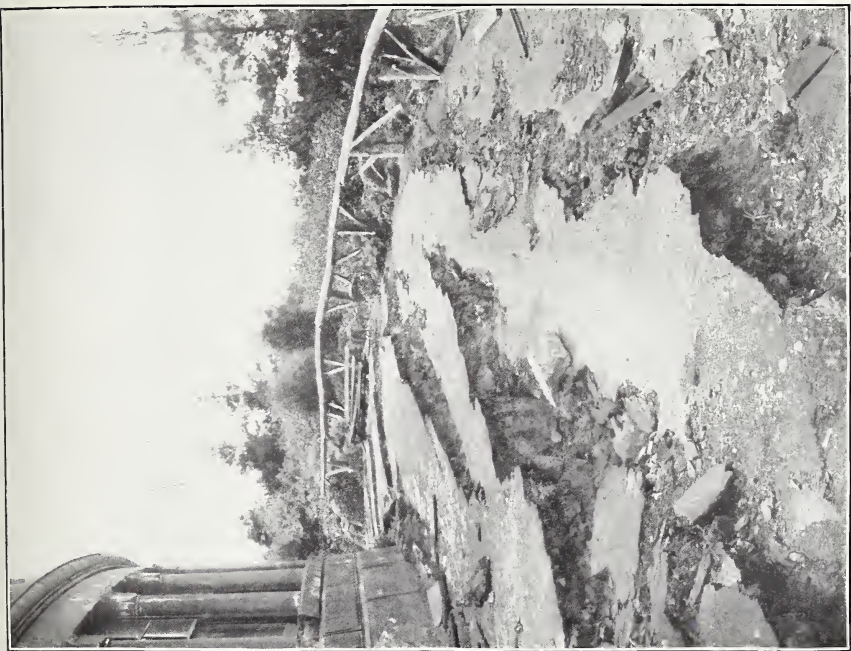
42. SLIP OF FOUNDATION OF CYCLORAMA, STRAWBERRY HILL, GOLDEN GATE PARK, SAN FRANCISCO, CAUSING COLLAPSE OF THE STRUCTURE.

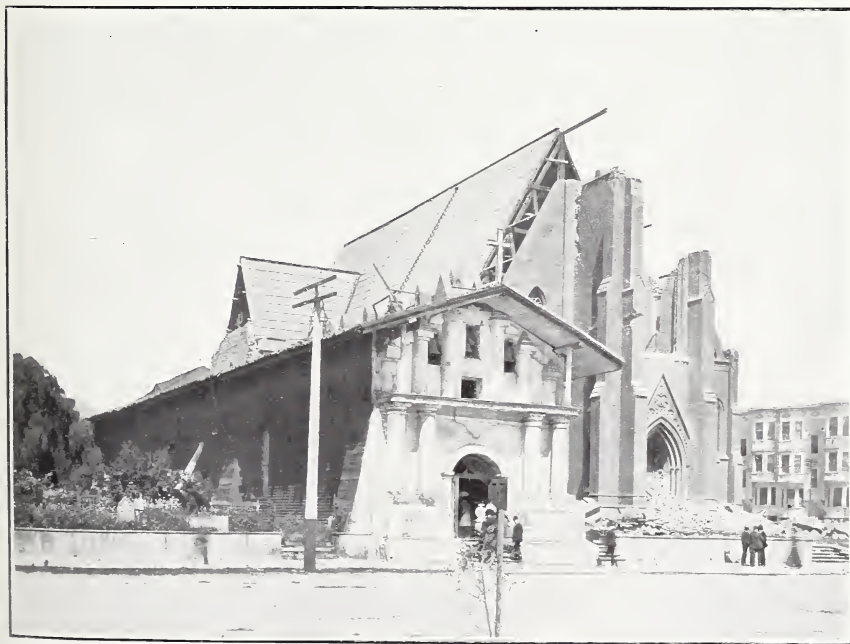
B. EFFECT OF EARTHQUAKE ON ADJACENT BUILDINGS OF DISSIMILAR TYPE AND CONSTRUCTION.

Old Mission Dolores, San Francisco, undamaged. Tower of new church adjoining was so badly damaged that it had to be taken down. Photograph by Richard L. Humphrey.

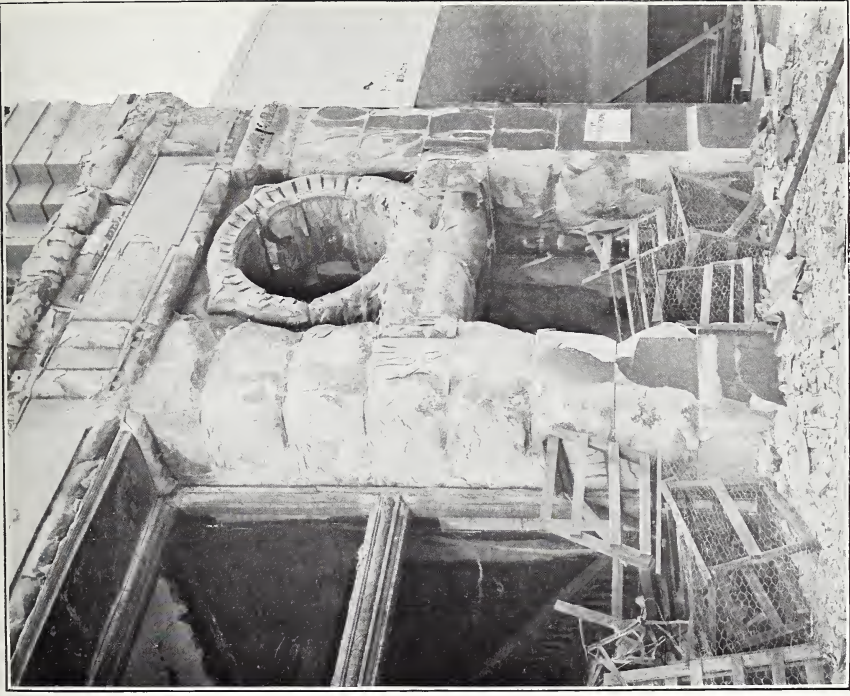
7. SPALLED GRANITE, MARKET STREET ENTRANCE OF AETNA BUILDING, SAN FRANCISCO

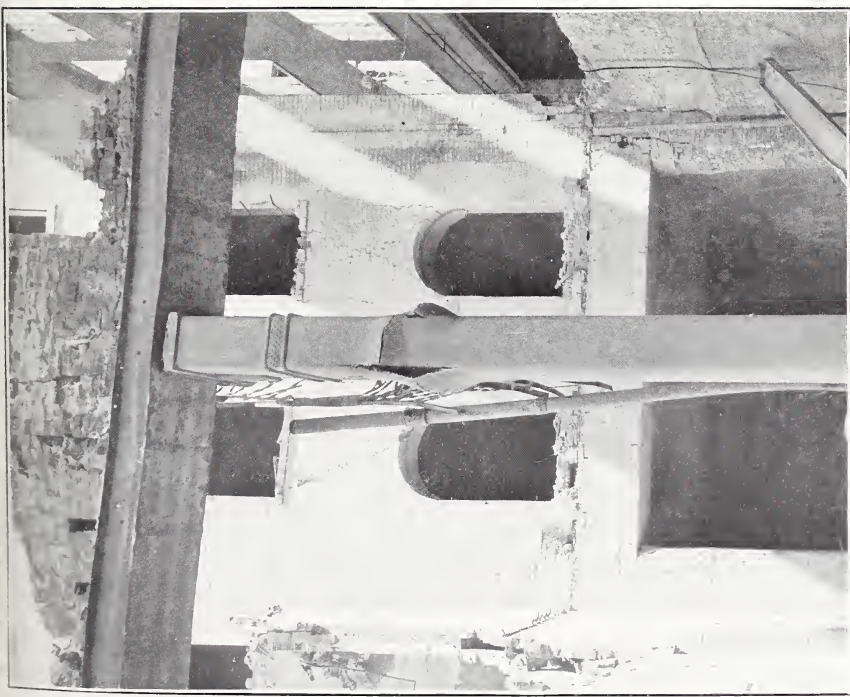
8. FAILURE OF CAST-IRON SHELL OF CONCRETE-FILLED CAST-IRON COLUMN BY FIRE, ACADEMY OF SCIENCES BUILDING, SAN FRANCISCO

The concrete core supports the load. Note also the effect of the earthquake on the brick wall in the rear. Photograph by Richard L. Humphrey.

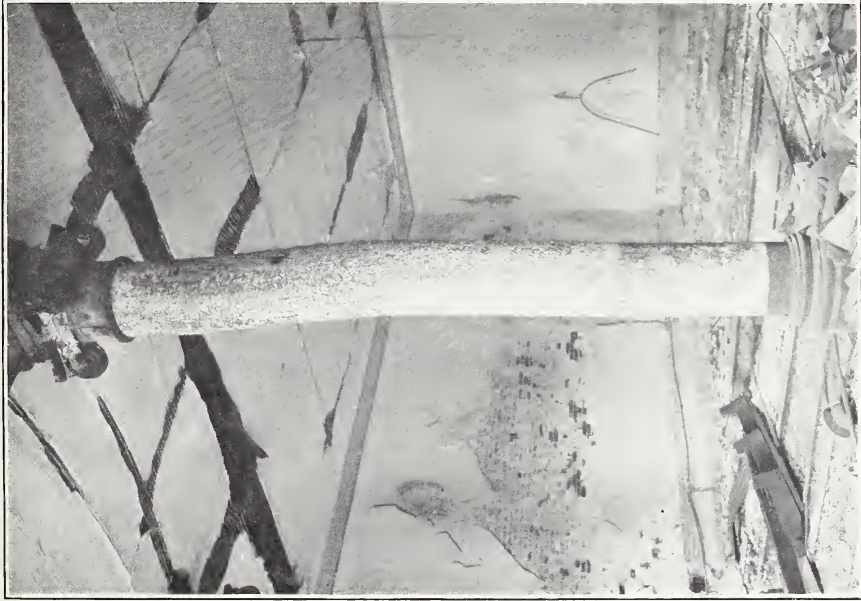
B. INCIPENT FAILURE OF NAKED CAST-IRON COLUMN IN CITY HALL, SAN FRANCISCO.

Ceiling on the point of falling. Photograph by John Stephen Sewell.

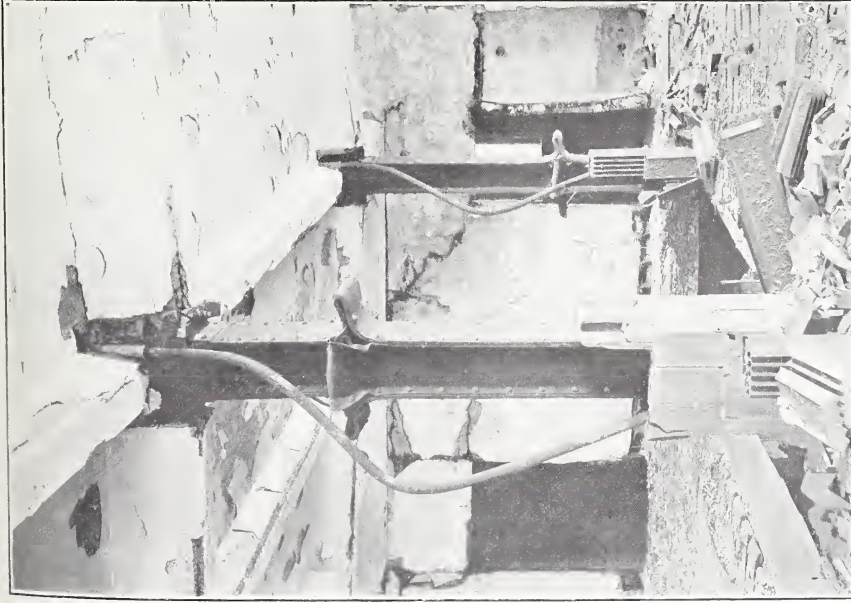
A. BUCKLED COLUMNS AND COLLAPSED FLOOR PANEL, BULLOCK & JONES BUILDING, SAN FRANCISCO.

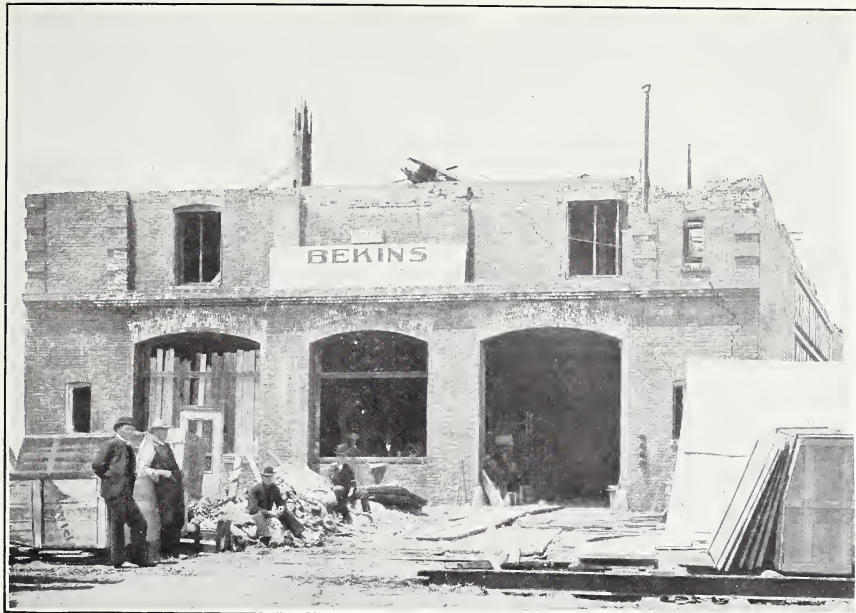
A. EARTHQUAKE ENDURANCE OF REENFORCED-CONCRETE BUILDING, BEKINS VAN AND STORAGE COMPANY'S WAREHOUSE, SAN FRANCISCO, UNDER CONSTRUCTION.

The only building of pure reinforced-concrete type in the city. The brick walls composing the shell of the building were cracked, but the reinforced-concrete floors and columns were uninjured. Photograph by Richard L. Humphrey.

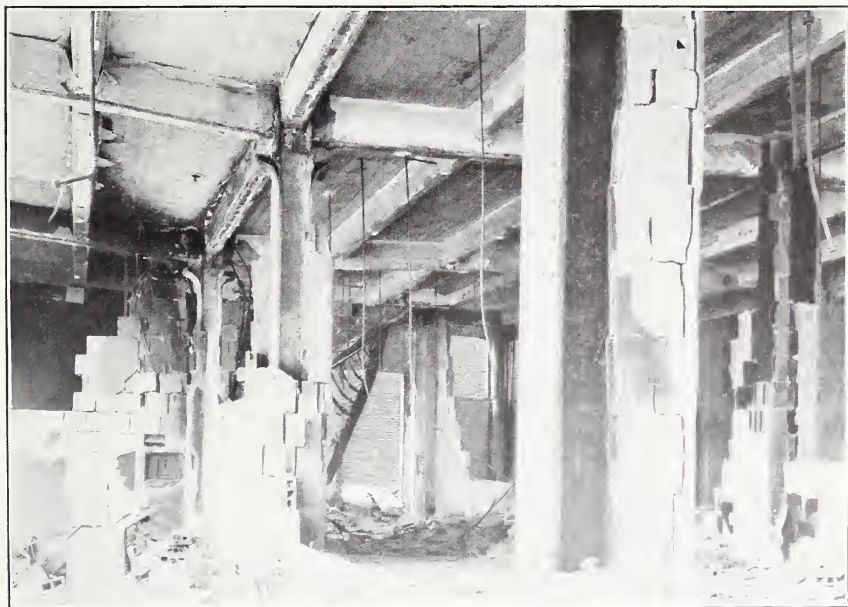
B. FAILURE OF TERRA-COTTA COLUMN COVERINGS, RESULTING IN BUCKLED COLUMNS; ENDURANCE OF CINDER-CONCRETE FLOORS; CENTER OF GROUND FLOOR, ARONSON BUILDING, SAN FRANCISCO.

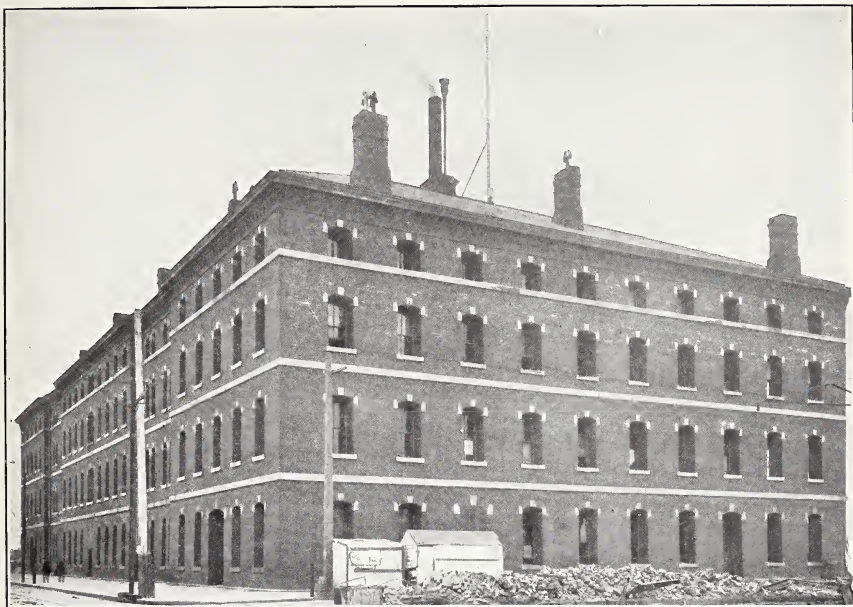
A. EARTHQUAKE ENDURANCE OF A WELL-CONSTRUCTED BRICK BUILDING: APPRAISERS' WAREHOUSE, SAN FRANCISCO.

The walls were built with full-header courses and show only a few slight cracks, although the building was located on alluvial soil. Photograph by Richard L. Humphrey.

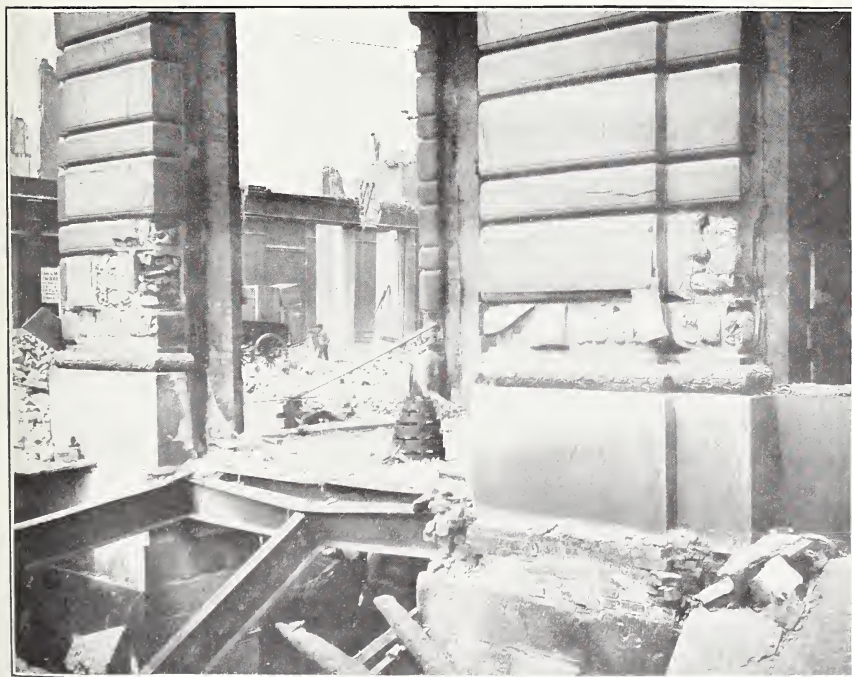
B. FAILURE OF ORNAMENTAL TERRA COTTA, CROCKER ESTATE BUILDING, SAN FRANCISCO.

This terra cotta failed, though solidly filled with brick mortar. The damage shown was probably due to fire, although damage of this kind was caused by both earthquake and fire. Photograph by John Stephen Sewell.

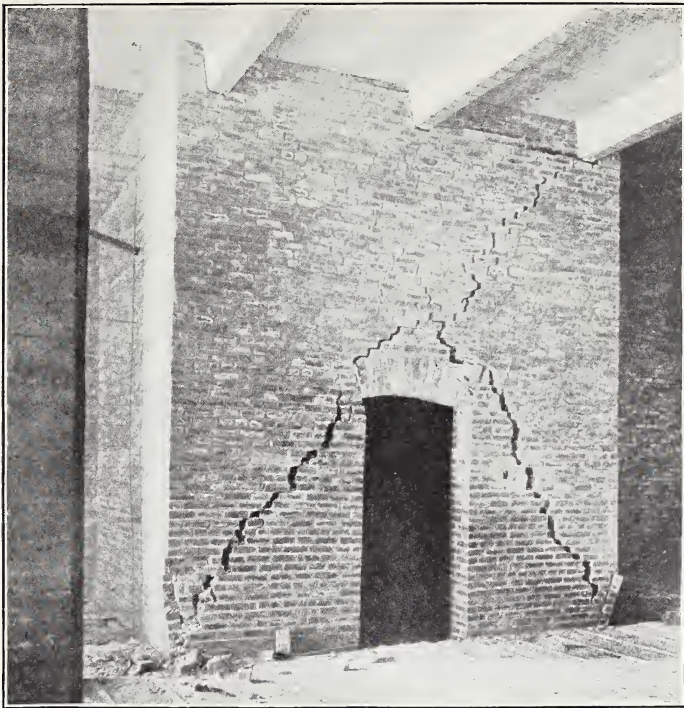
A. EARTHQUAKE CRACKS IN WALL OF VAULT, CALIFORNIA CASKET COMPANY'S BUILDING, SAN FRANCISCO.

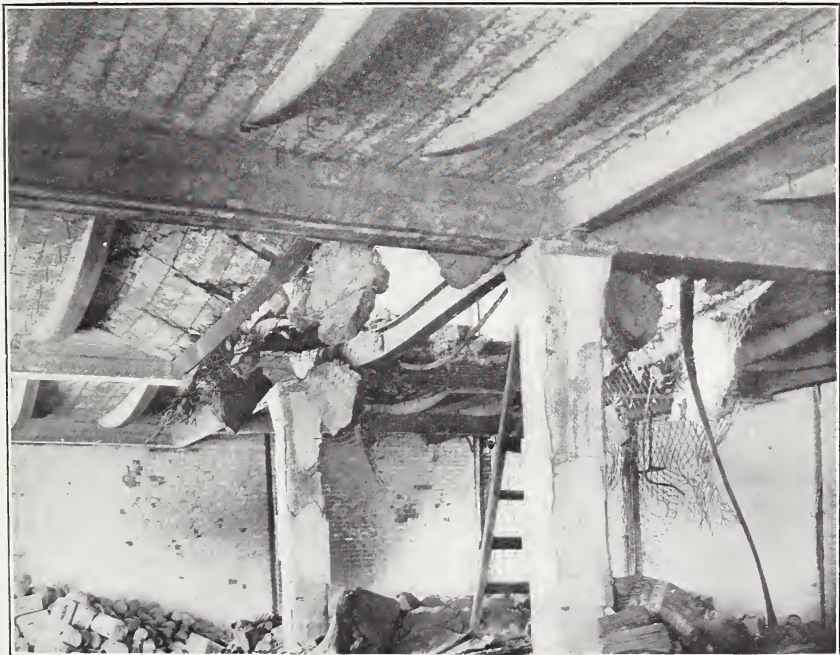
B. COLLAPSE OF FLOOR PANEL, CAUSED BY LOAD FALLING FROM A FLOOR ABOVE, THIRD FLOOR OF ÆTNA BUILDING, SAN FRANCISCO.

The failure of the upper floor was due to the softening by heat of reinforcing steel bands. Photographs by Richard L. Humphrey.

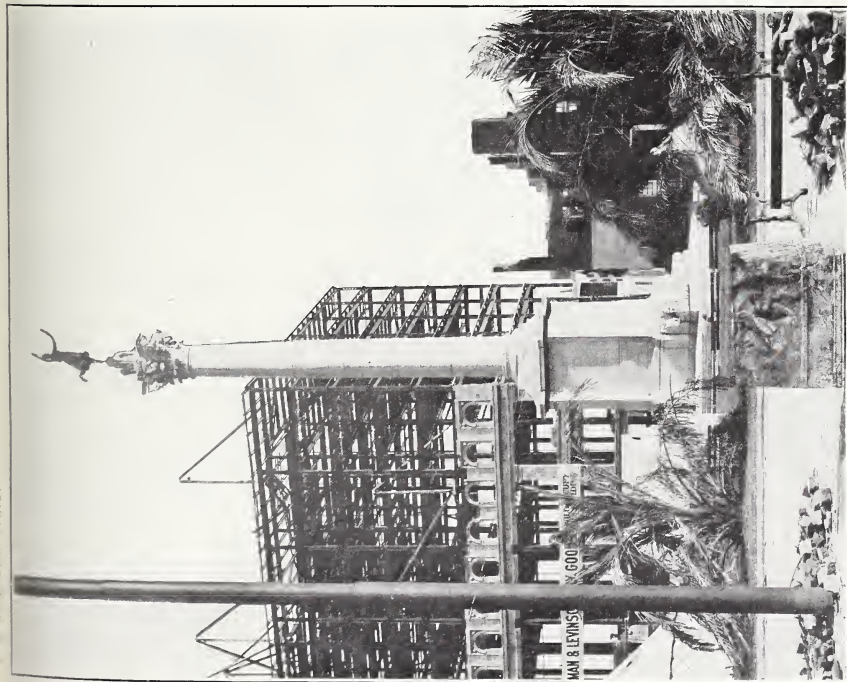
1. EARTHQUAKE DAMAGE MINIMIZED BY SPECIAL CONSTRUCTION, DEWEY MONUMENT, SAN FRANCISCO.

The drums on the shaft were displaced slightly, but were kept from falling by a steel core. Photograph by John Stephen Sewell.

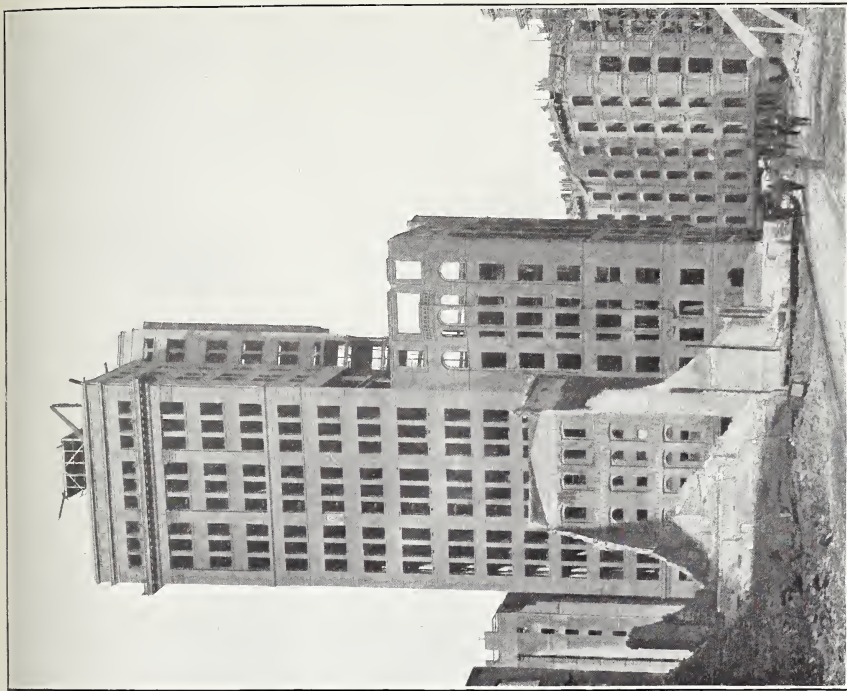
2. X CRACKS IN WALLS, DUE TO ROCKING OF BUILDING BY EARTHQUAKE, CHRONICLE BUILDING AND ANNEX, SAN FRANCISCO, LOOKING EAST.

The Palace Hotel (at the right) was completely gutted by fire, but the walls remained in good condition. Photograph by Richard L. Humphrey.

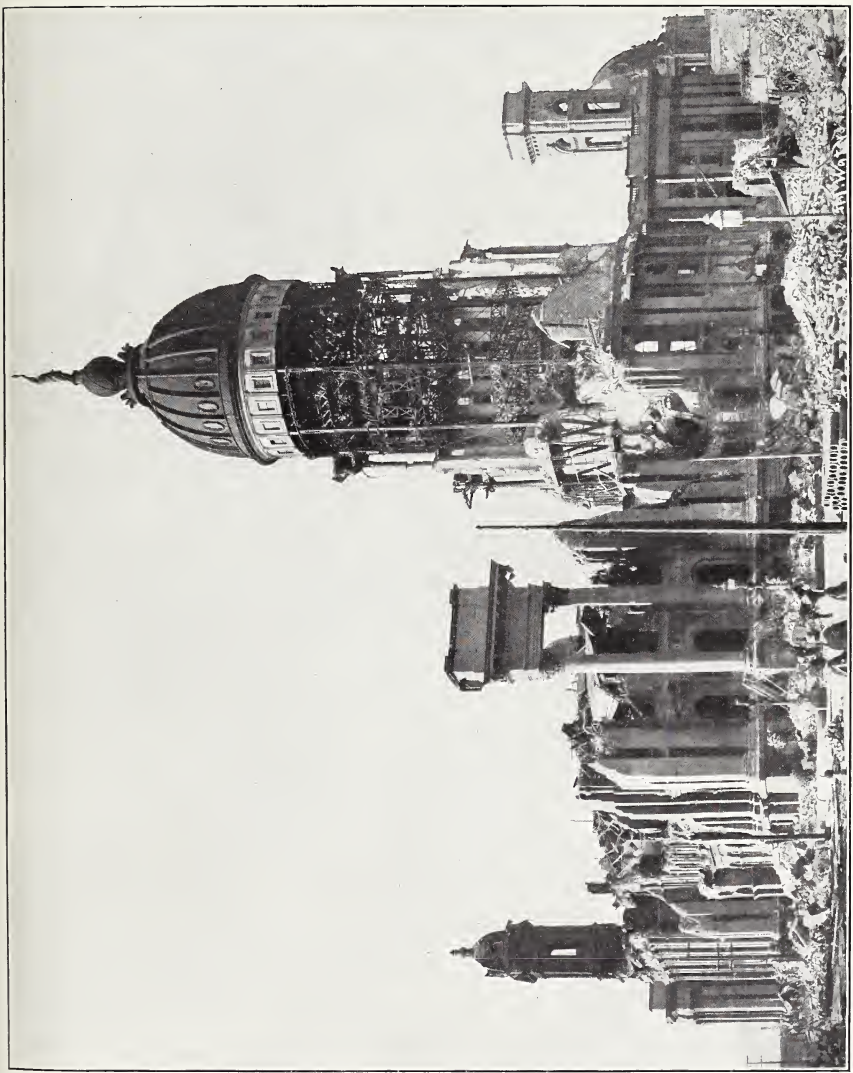
RUIN OF THE \$7,000,000 CITY HALL, SAN FRANCISCO, BY EARTHQUAKE AND FIRE.

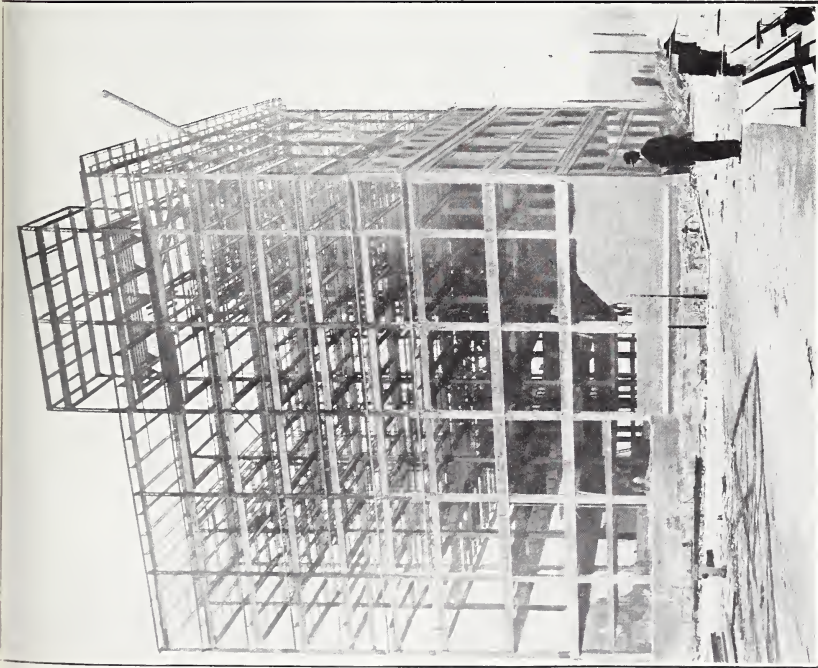
4. BEHAVIOR OF STEEL FRAME, BUTLER BUILDING (INCOMPLETE), AT THE SOUTHWEST CORNER OF GEARY AND STOCKTON STREETS, SAN FRANCISCO.

Walls taken down in places because of earthquake damage, although damage to steel by earthquake and fire was nominal. Photograph by John Stephen Sewell.

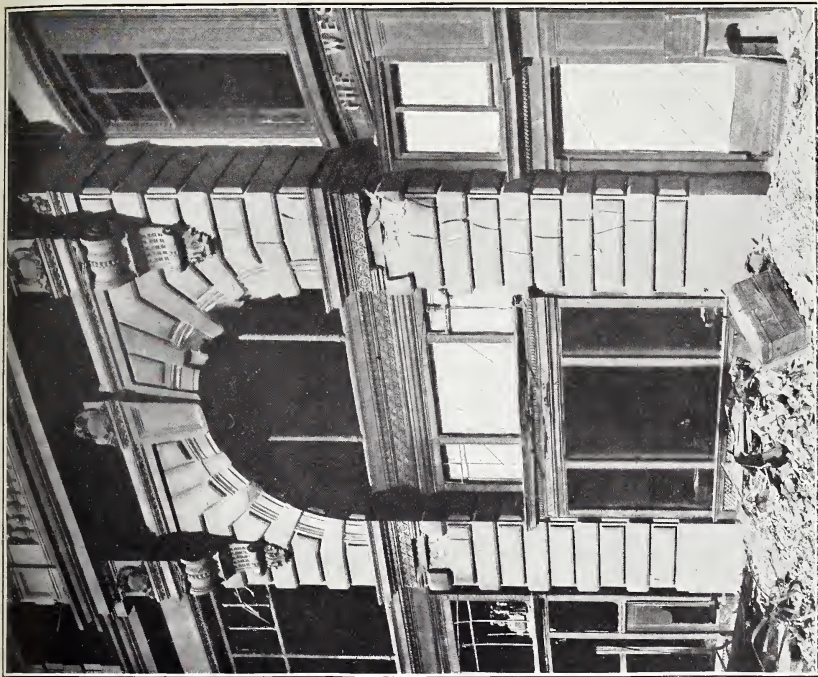
7. EARTHQUAKE DAMAGE TO STONE PIERS, JAMES FLOOD BUILDING, SAN FRANCISCO.

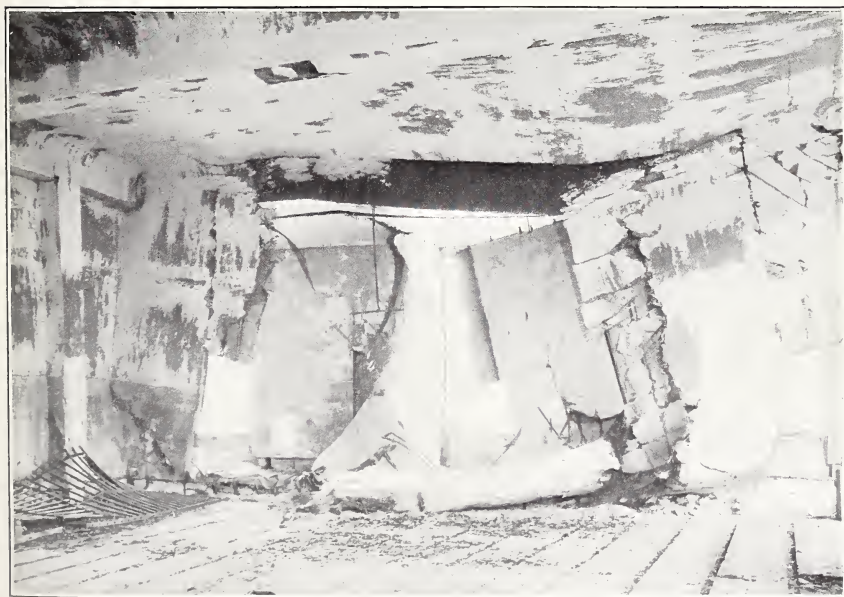
B. FAILURE OF SUSPENDED CEILING, HALL OF JUSTICE, SAN FRANCISCO.

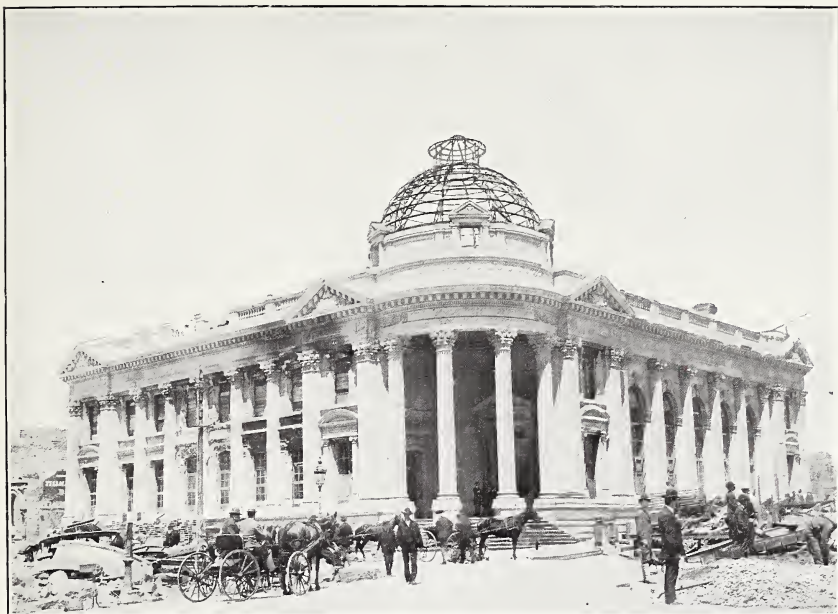
A. STONWORK SPALLED BY FIRE, HIBERNIA SAVINGS AND LOAN SOCIETY'S BUILDING, SAN FRANCISCO.

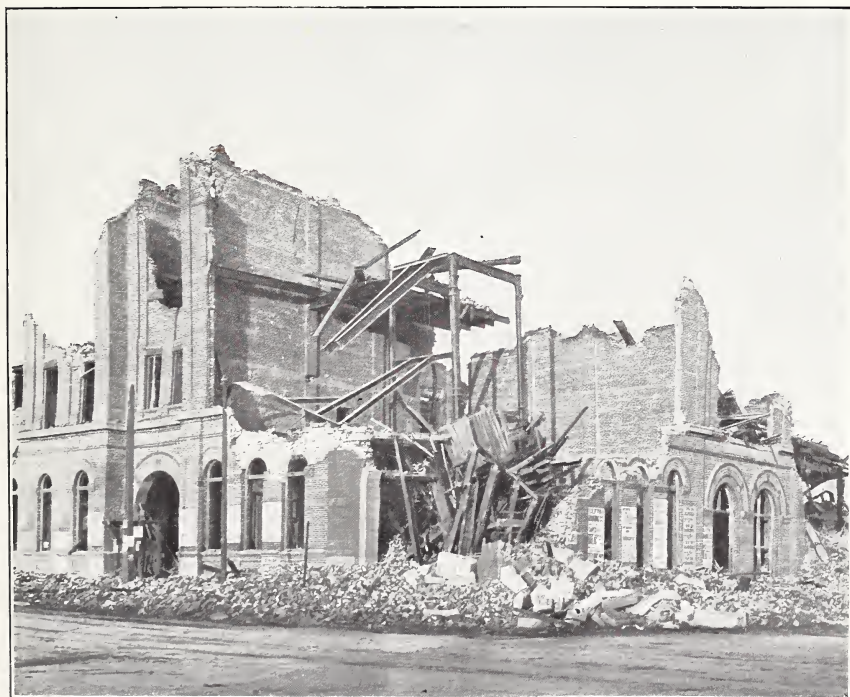
B. EARTHQUAKE DAMAGE, JACKSON BREWING COMPANY'S BUILDING, SAN FRANCISCO.

Light walls, badly bonded and laid up with poor lime mortar, and flimsily constructed steel work. Photograph by Richard L. Humphrey.

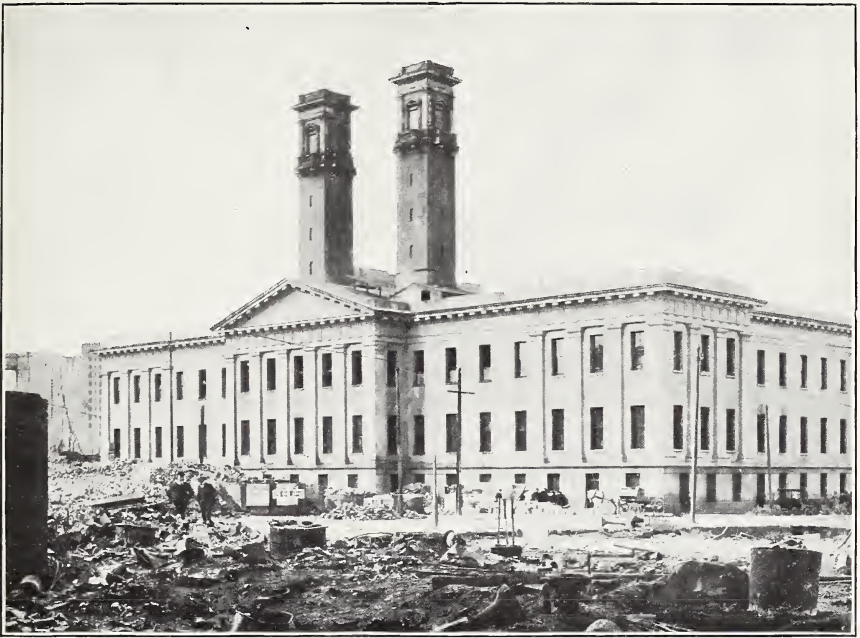
A. GOOD EARTHQUAKE ENDURANCE OF A BUILDING OF THE MONUMENTAL TYPE: UNITED STATES MINT, SAN FRANCISCO.

Showing only slight damage to brick stack, probably due to earthquake. Photograph by John Stephen Sewell.

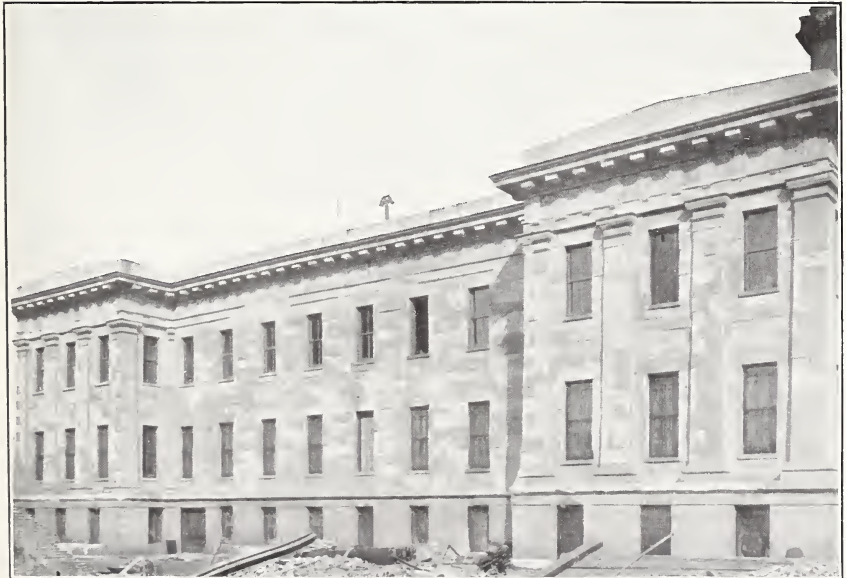
B. SPALLING OF STONWORK BY FIRE, NORTHWEST FRONT OF UNITED STATES MINT.

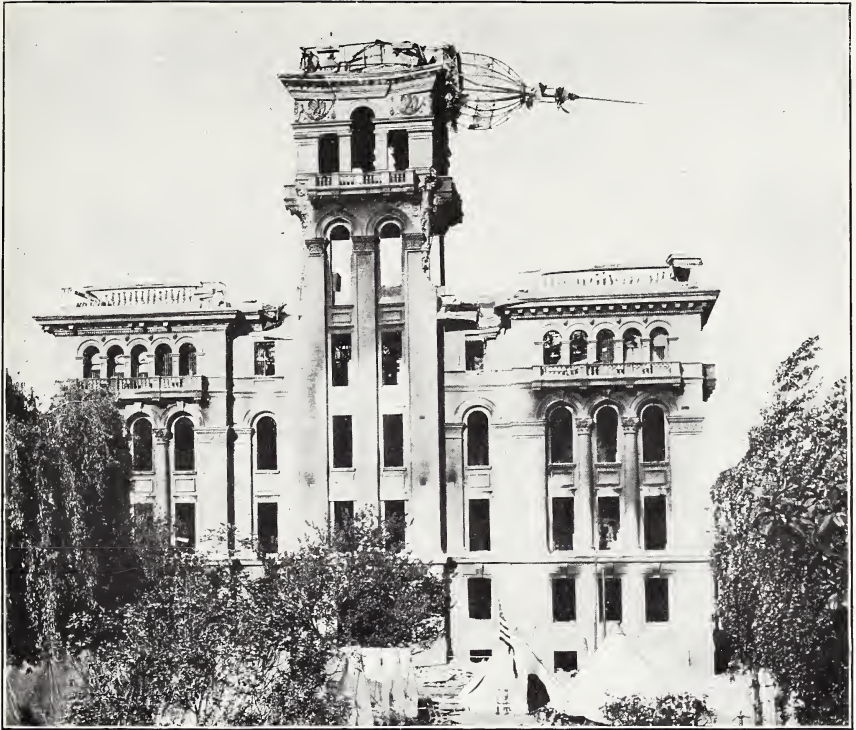
A. WRECKED TOWER AND SPALLED STONWORK, HALL OF JUSTICE, SAN FRANCISCO.
Photograph by John Stephen Sewell.

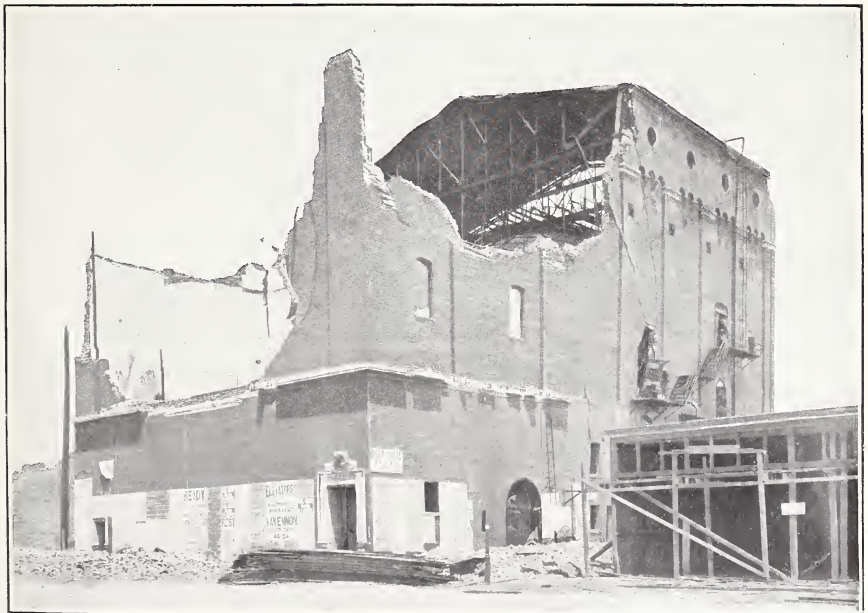
B. COMPLETE WRECK BY EARTHQUAKE, DUE TO POOR DESIGN, MAJESTIC THEATER,
SAN FRANCISCO.
Photograph by Richard L. Humphrey.

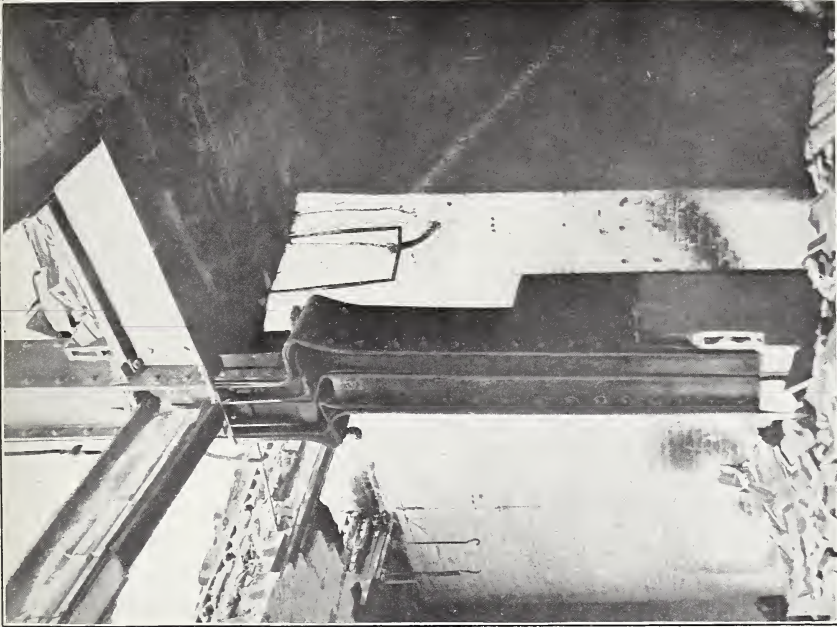
2. BUCKLING OF BASEMENT COLUMN DUE TO FAILURE OF TERRA-COTTA COVERING IN FIRE, MILLS BUILDING, SAN FRANCISCO.
 Photograph by Richard L. Humphrey.

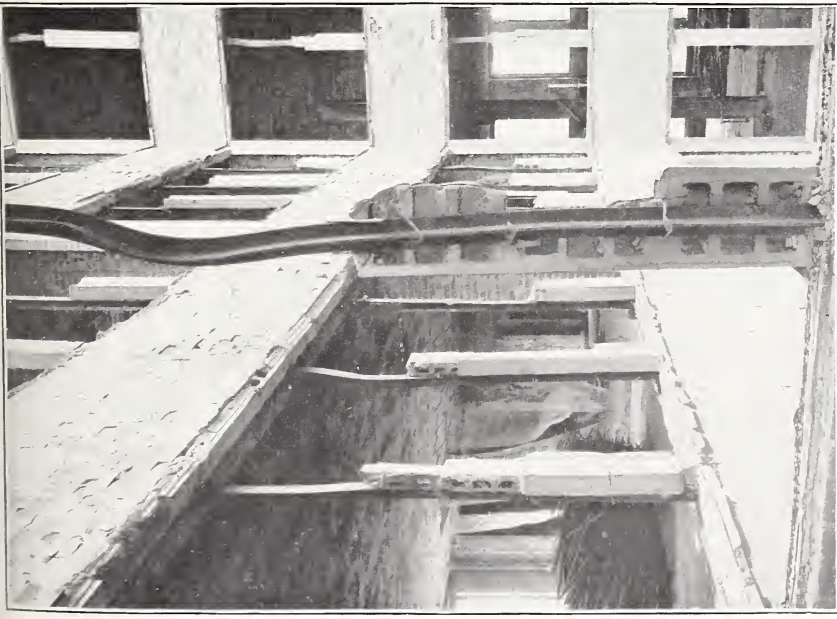
1. SPALLING OF ENAMELED BRICK IN LIGHT WELL, AND FAILURE OF FIREPROOFING OF WINDOW-FRAME SEPARATORS, MERCHANTS' EXCHANGE BUILDING, SAN FRANCISCO.
 Photograph by Richard L. Humphrey.
